JOINT ARRIS REPAIR DETAIL - Type 3 Repair

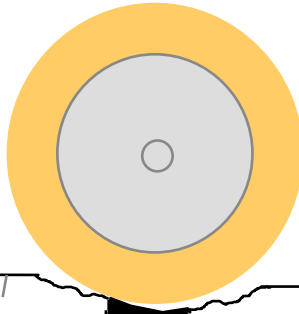
Existing problem

Hard wheels of materials handling equipment impact against the joint edges, initially creating and then increasing the extent of the damage.

Any slight step between adjacent floor slabs will exaggerate damage to the joint edges, or arrisses. Wheels, tyres and bearings all suffer damage due to the impacts endured as they travel across joints.

Existing joint sealant is typically too soft, compressed or de-bonded from the floor slab edges.

Wide joints suffer the most damage.

Joint sealant should be hard enough to withstand the impact loads from wheeled traffic and yet be flexible enough to allow movement in the floor slabs.

The repair and adjacent floor surface will be ground smooth to ensure a smooth transition for wheeled traffic.

A 35mm deep saw cut is made around the perimeter of the proposed repair. i.e. No feather-edge to the repair mortar

New 5mm wide joint width is fully filled with a suitable joint sealant ('Shore A' hardness of 65 - 80)

Repair depth to be a minimum of 35mm.

All surfaces of the joint cavity are primed, with an epoxy bonding agent, prior to filling with the repair mortar.

The repair mortar replaces the damaged corners of the concrete floor slabs

Typical repair width of 100 to 120mm, determined by extent of existing edge damage.

The min. 20mm deep joint sealant is given additional support from a polyethylene backing bead that is inserted into a 5mm wide saw cut through the cured repair mortar. Alternatively a 'cast in place' polystyrene joint former can be used, in lieu of the backing bead and saw cut.

Joint repair base to be roughly scabbled to provide a good mechanical bond between the floor and the repair materials.

Any existing joint material can be retained beneath the repair.
