COVERMETER SURVEYS

Could Steel Reinforcement Be Affecting Your Wire-Guided MHE?

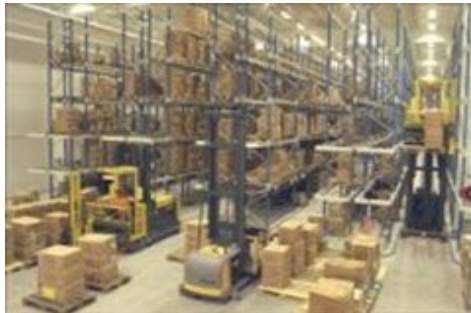
A typical VNA Installation

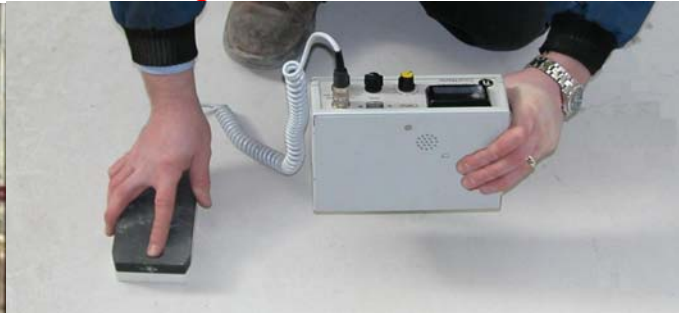
The FACE Covermeter

In both situations a [FACE Consultants](#) Covermeter Survey gives an accurate indication of the depth of steel reinforcement within the floor and clearly indicates in the Survey Results (example above) precisely where each potential guidance problem may occur.
